Scanning and Fabricating a Replacement Longeron

Using a ZScanner 800 3D laser scanner and Rapidform[®] software, Reverse Austin designed a replacement section of a longeron with integral doubler (splice).

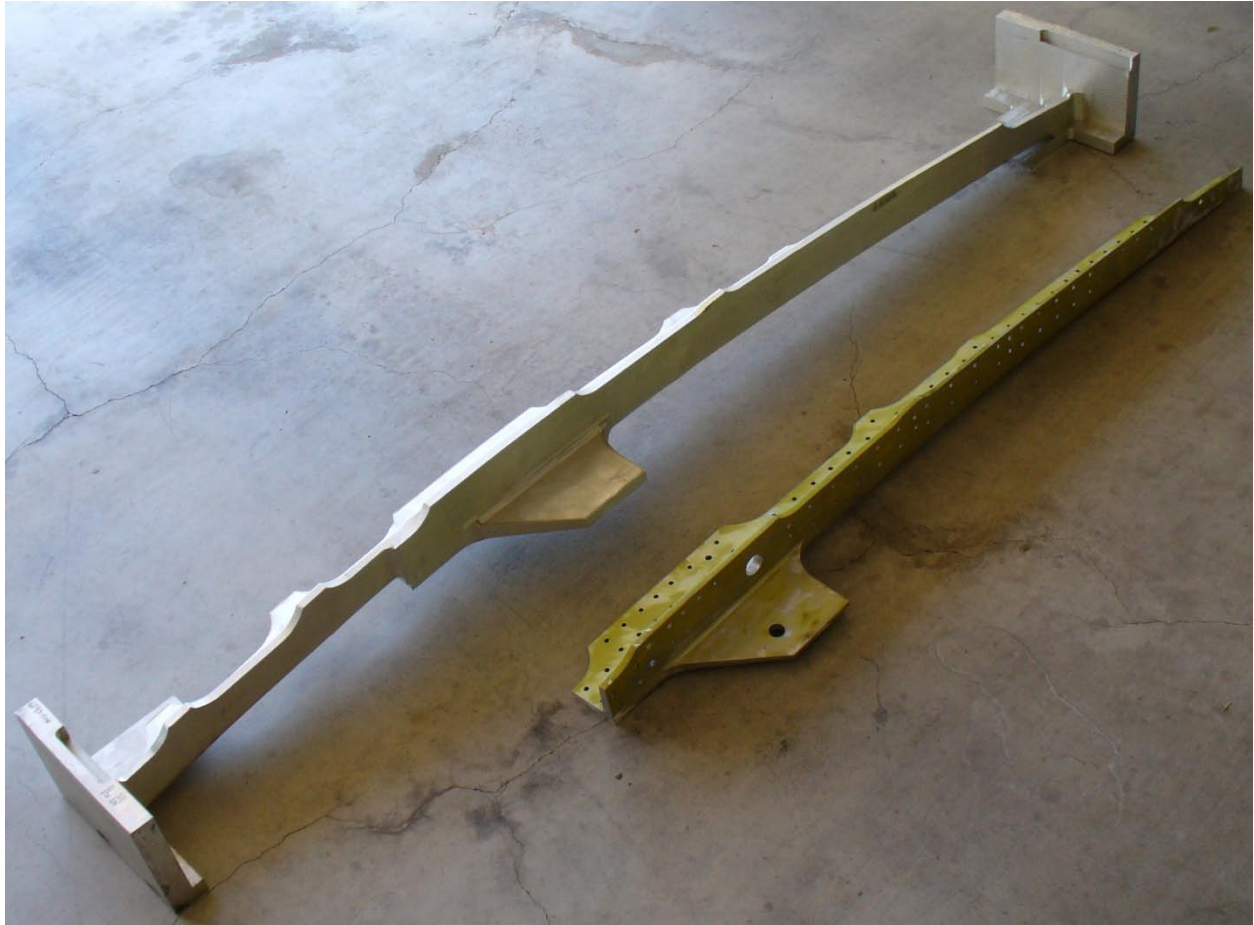
Shown above is the removed 4' long section of cracked longeron alongside a pre-machined blank. Not shown is a 2' long plaster cast of the inside of the longeron made prior to removal. The plaster cast spanned a 1' section to either side of the cut made to remove the longeron piece.

The longeron section, the plaster cast and the pre-machined blank were all scanned with the laser. The data were imported into Rapidform[®] where CAD models (solid models) were created for each piece.

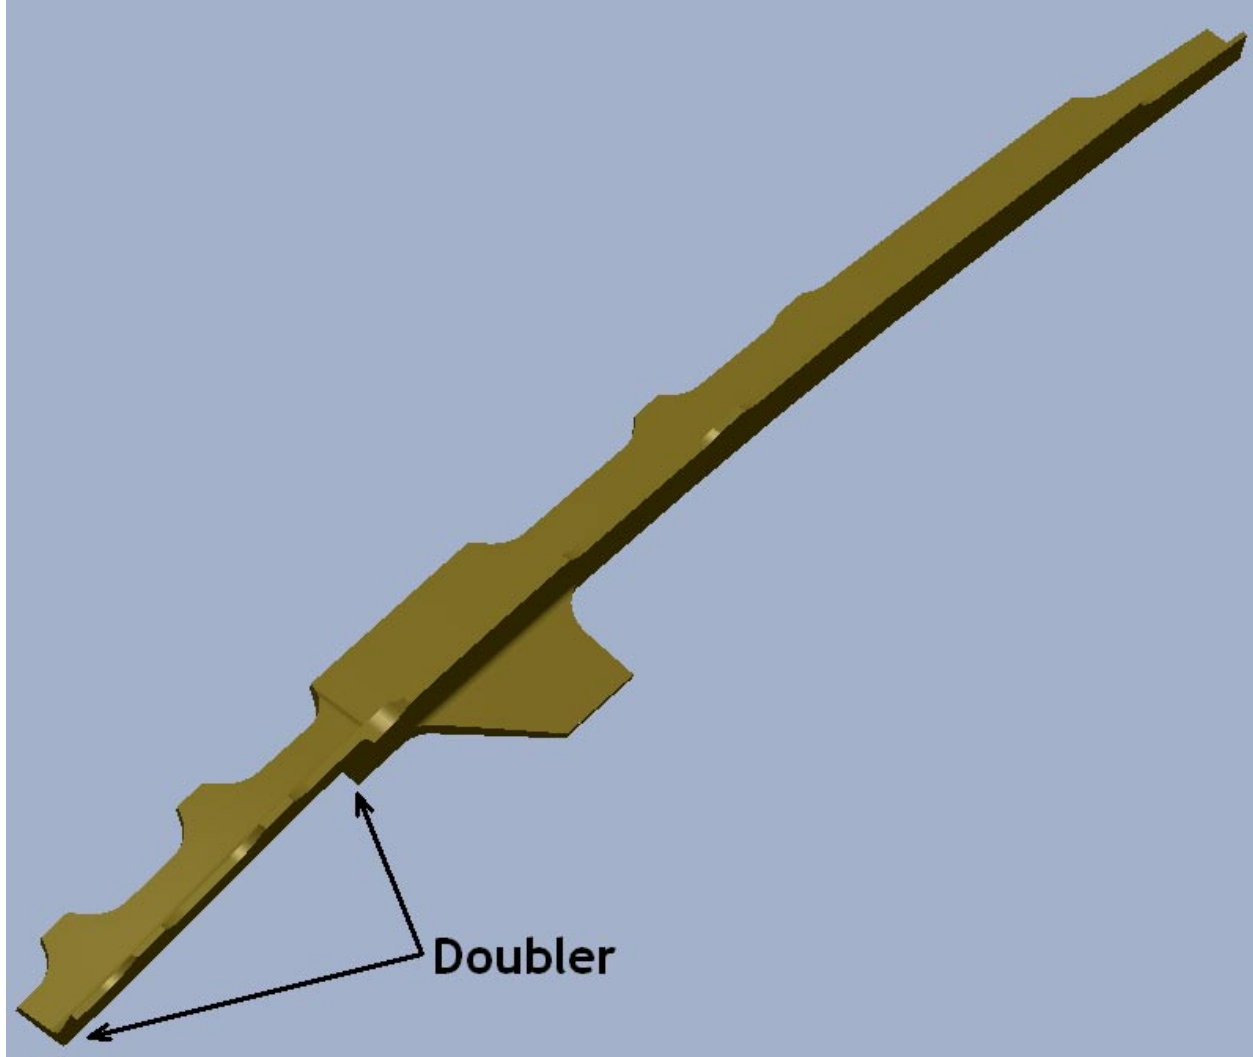
The models were used to design the replacement longeron with integral doubler (below).

Using Solid Edge[®] CAD software, the replacement was best fit inside the pre-machined blank to insure 100% cleanup. The CAD assembly was exported as a Parasolid file and used to program the CNC machine tool that machined the finished part.
